Implant Breakage in Proximal Femoral Nails: Design, Metallurgy and Failures

This thesis is presented for the degree of Master of Surgery of
The University of Western Australia

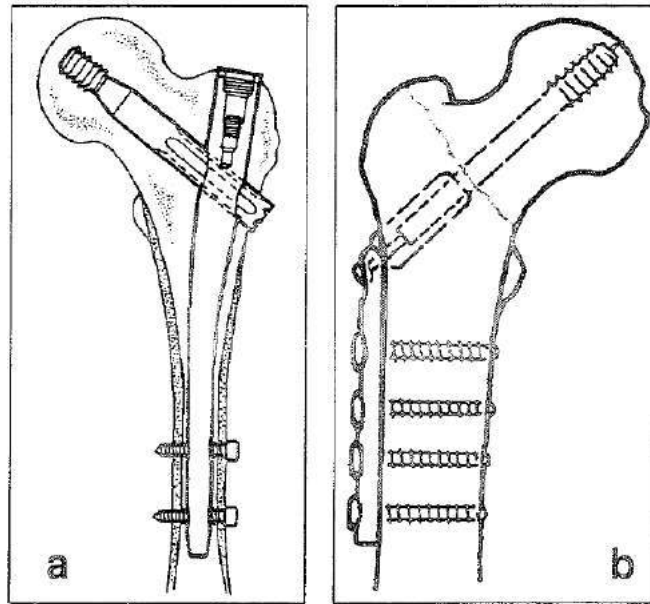
Figure 1.3 Nail and DHS

An intramedullary nail 'a' and a sliding hip screw (Dynamic Hip Screw (DHS)), 'b' is shown. Source: Kukla et. al.⁸

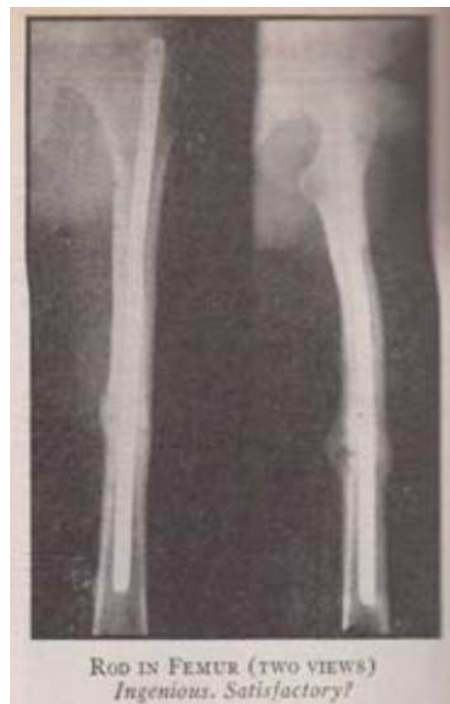
Figure 1.6 The Amazing Thighbone

Radiographs included in the post-war article that spread word of intramedullary nailing. Source: Time Magazine.²⁴

The intramedullary nailing method for stabilising femoral fractures became more popular subsequent to the ensuing World War II where Gerhard and other Finnish surgeons with whom he worked implanted nails, and surgeons in other countries cared for returned veterans discovering such 'daring' devices had been implanted when injured in duty.¹⁸ Interest in nailing progressed further after the publication in Time magazine on March 12, 1945 called "The Amazing Thighbone" depicting radiographs of a returned soldier

(Figure 1.6) that still questioned the validity of nailing – “*Ingenious. Satisfactory?*”

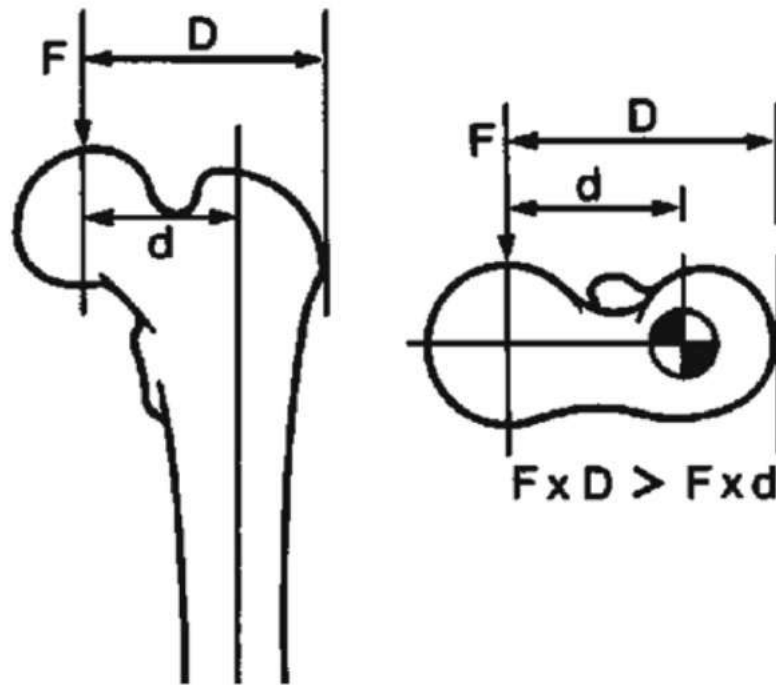
Figure 1.10 Shortened Lever Arm of Intramedullary Nails

Depiction of the advantageous reduced lever arm ‘d’ in intramedullary nails compared to side plating, ‘D’. Source: Muller-Daniels, H.¹⁹

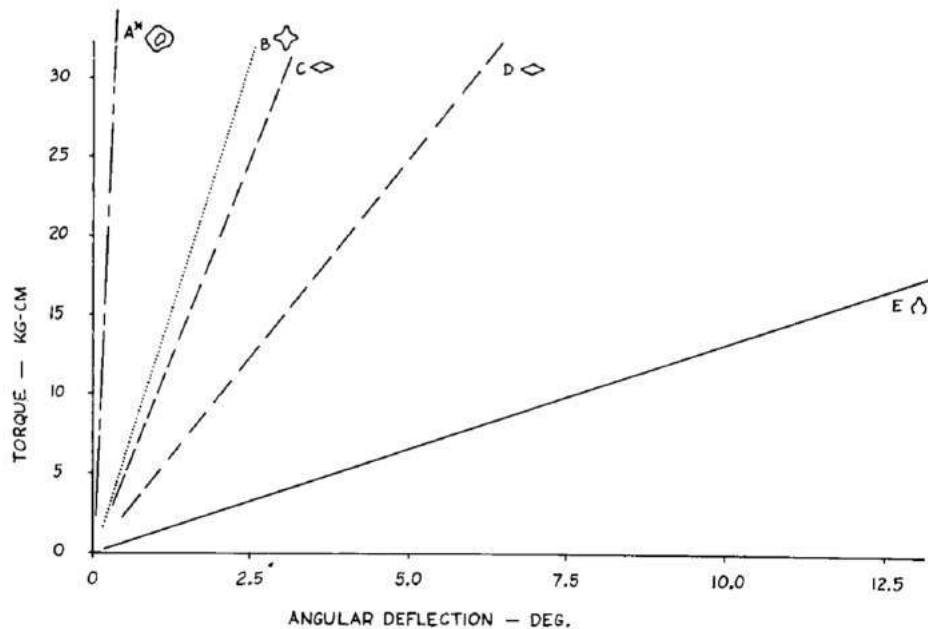
Figure 1.11 Angular Deflection of Nail Designs

(diamond, cloverleaf, round) but also the changes with the orientation of the nail.³⁵ In particular those with an open section ('slotted' nails) were shown to have a polar moment of inertia 50 times less than those without (so-called 'non-slotted' nails) leading to the conclusion from Allen et. al. in 1968 that open section structures should from thereafter be avoided.³⁵ The differences between some of the different early design patterns are illustrated in Figure 1.11.

Relative angular deflection of bone (the femur; A*), the Schneider nail (B), a short (C) and long (D) diamond nail and a cloverleaf nail (E). Source: Allen et. al.³⁵

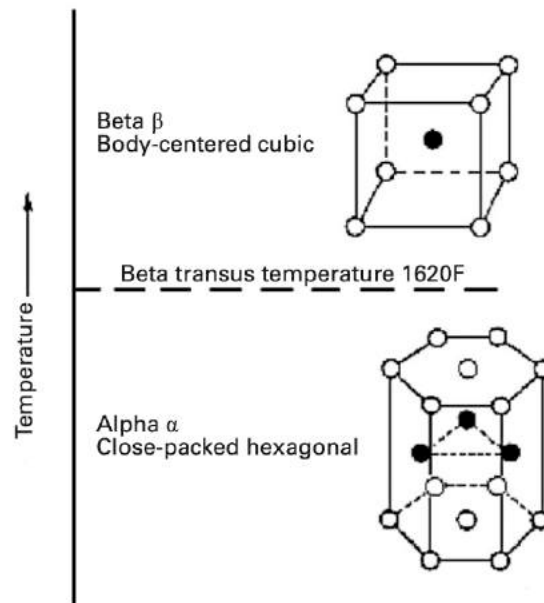
Figure 1.12 Alpha and Beta Titanium Phases

The 2 crystalline phases of titanium alloys. Source: Froes et. al.⁴⁵

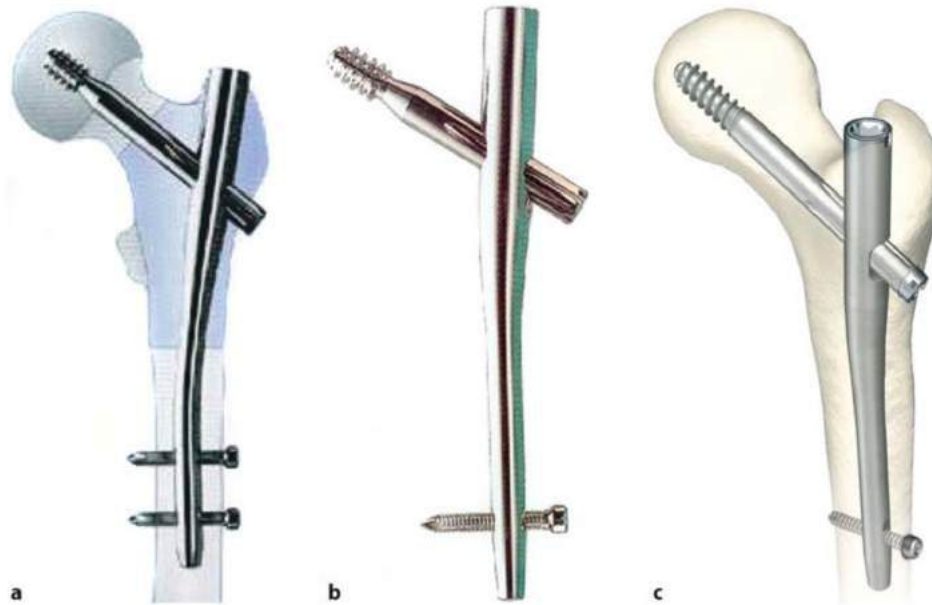
Figure 4.1 Generations of Gamma Nails

The progression of Gamma nails from the SGN ('a'), TGN ('b') to Gamma3 ('c').
Source: Müller-Daniels.¹⁹

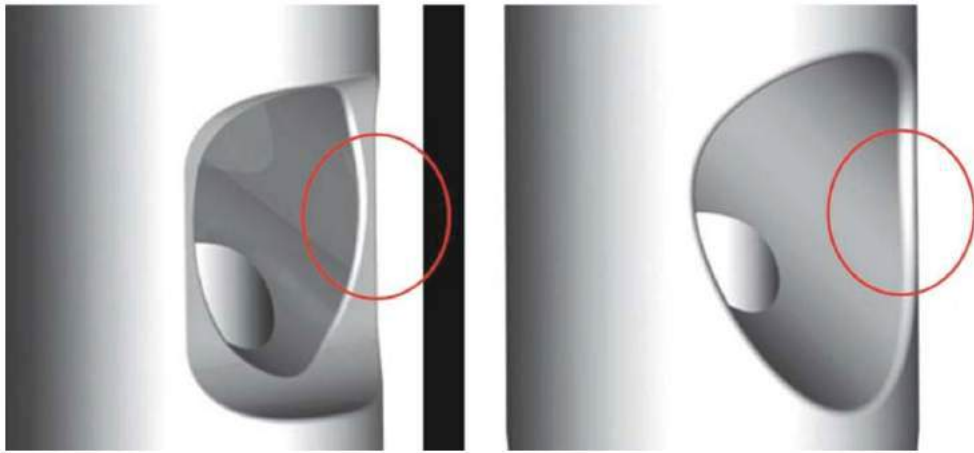
Figure 4.2 Gamma3 Strength Improvement Groove

The Gamma3 also introduced a Strength Improvement Groove (SIG) on the lateral aspect of the proximal aperture (Figure 4.2), shown in Finite Element Analysis (FEA) models to share the stress over a greater area, thereby reducing the maximal stress at any point (Figure 4.3).

The cut out on the lateral part of the aperture known as the SIG is shown here (left) compared to the appearance without a SIG (right), which blunts the edges. Source: Müller-Daniels.¹⁹

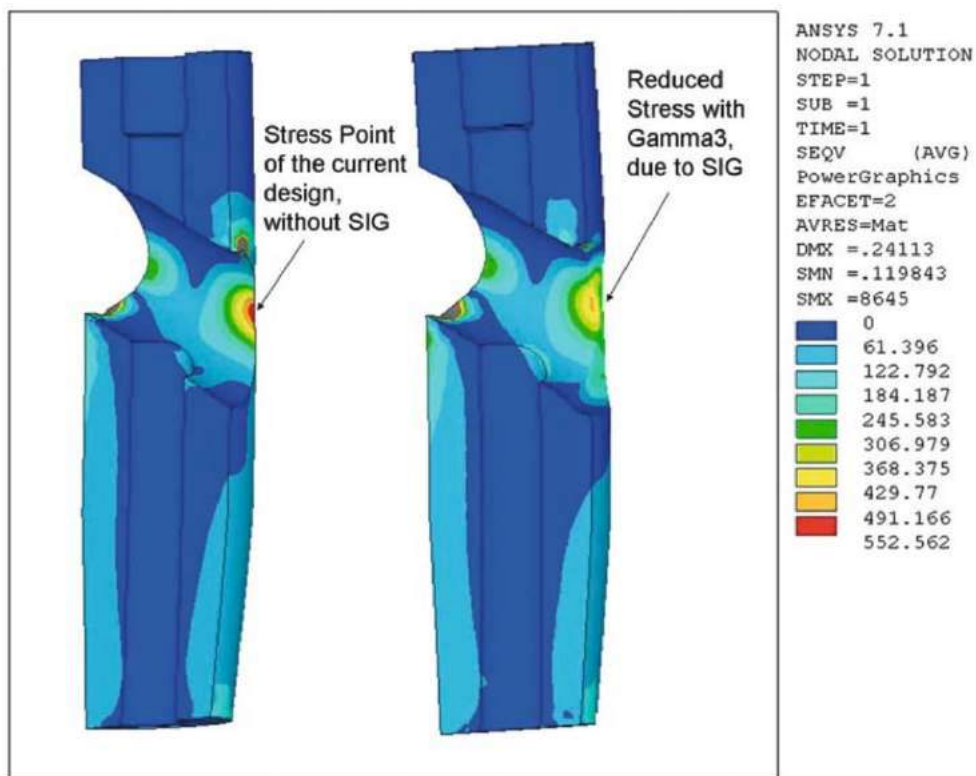
Figure 4.3 Finite Element Analysis of the Gamma SIG

FEA for the proximal aperture in the Stryker Gamma nail without the SIG (left) and with (right). Source: Müller-Daniels.¹⁹

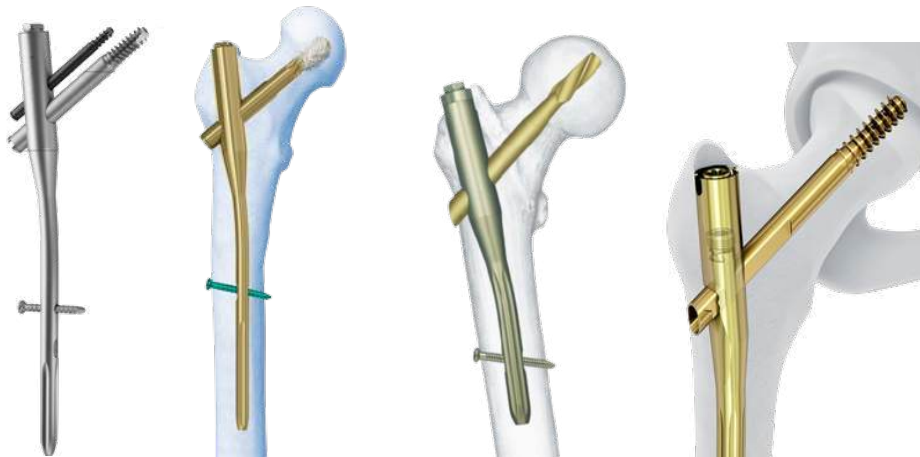
Figure 4.4 Evolution of Synthes Proximal Femoral Nails

Left to right, the PFN, PFNA, TFN and TFNA nails. Source: surgical technique guides.³¹⁻³⁴

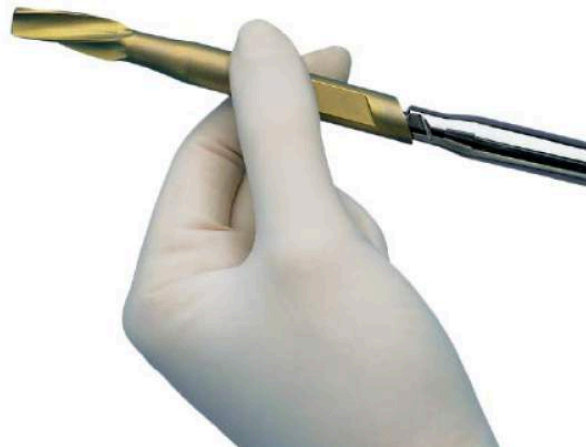
Figure 4.5 The TFN Helical Blade

The TFN was released in 2002 but was never available for use in Australia. The nail was only available as a TAN alloy (Synthes had ceased production of stainless steel nails, presumably due to the excessive stiffness). It also saw the introduction of a helical blade (rather than screws) at the proximal end. The blade was designed with the intention of enhancing cut-out resistance as well as preserving bone.³² The screw was controlled in rotation by a built-in internal set-screw proximally with two small arms that sat either side of an anterior and posterior flat (rather than round) surface of the lateral nail, as seen in Figure 4.5.

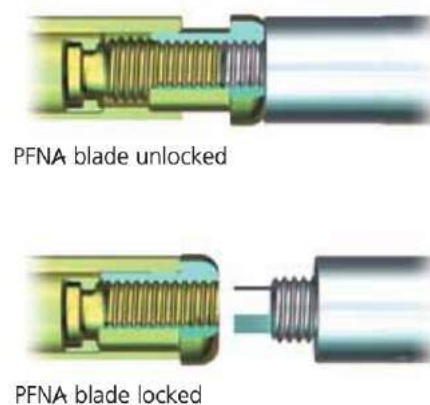
Figure 4.6 PFNA Lateral Locking Mechanism

Demonstration of the internal locking mechanism to prevent blade rotation. Source: Synthes Product Technique Guide.⁵⁴

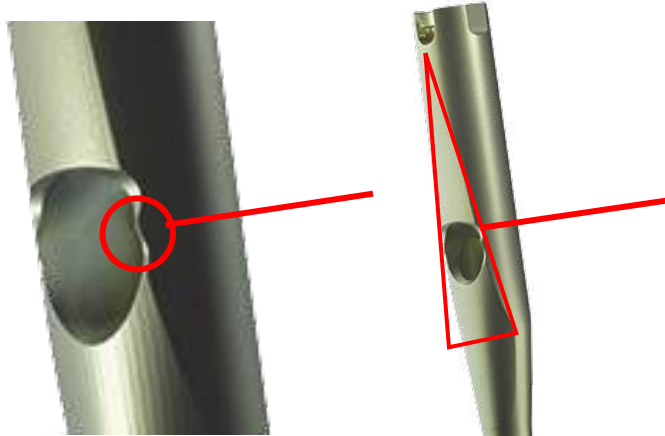
Figure 4.7 TFNA Bump and Lateral Relief Cuts

Other introduced features of the TFNA include a 1.0m radius bow and a smaller proximal nail diameter of 15.66 mm thereby further preserving bone. The BUMP CUTTM design is said to improve fatigue strength and is a protuberance in the mid portion of the proximal aperture on the lateral side both on the anterior and posterior rims. The LATERAL RELIEF CUTTM was also introduced where the lateral portion of the proximal nail is progressively removed from proximal to distal leaving a flattened rather than cylindrical shape, again designed to preserve bone.³³ These features are shown in Figure 4.7.

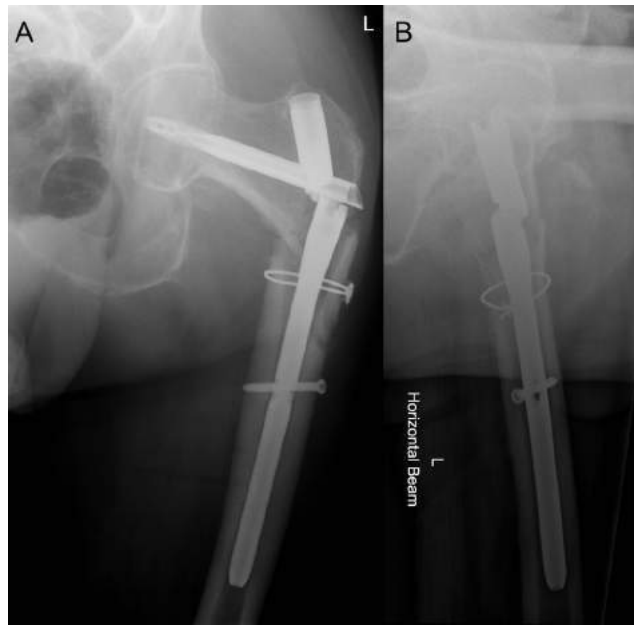
Figure 6.3 Implant Breakage in Case 3

Anteroposterior (A) and lateral (B) radiographs demonstrating implant breakage through the proximal aperture typical of this series

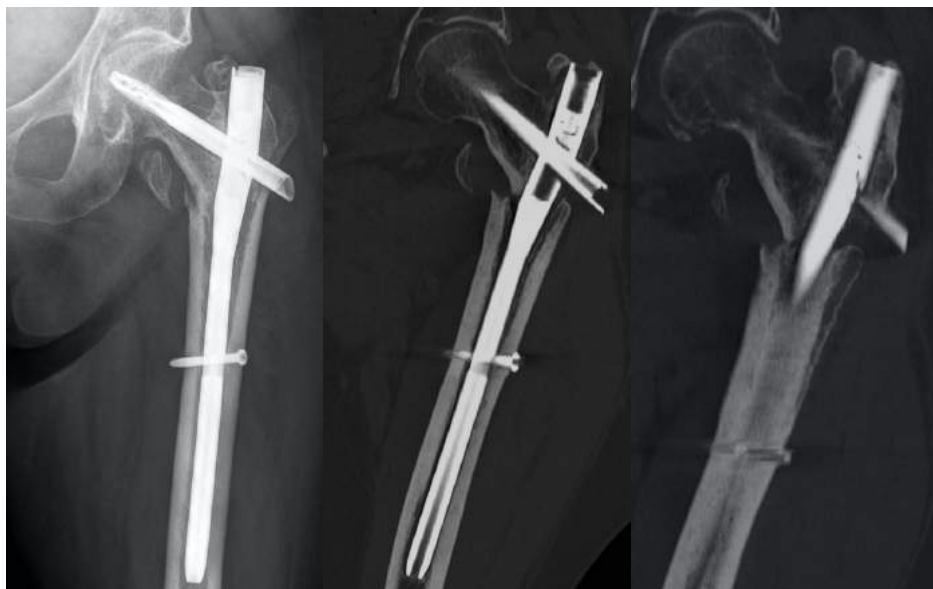
Figure 6.5 X-ray and CT of Case 1

It is worth noting that two of the cases of breakage presented with very subtle plain film findings and required CT to confirm implant breakage as catastrophic failure had not yet occurred. It is likely that some of the patients that presented with catastrophic failure (fracture displaced) may have had a window of opportunity for diagnosis and revision before this stage and one patient in fact retrospectively was identified as having a minimally displaced implant breakage on earlier films (Figure 6.5).

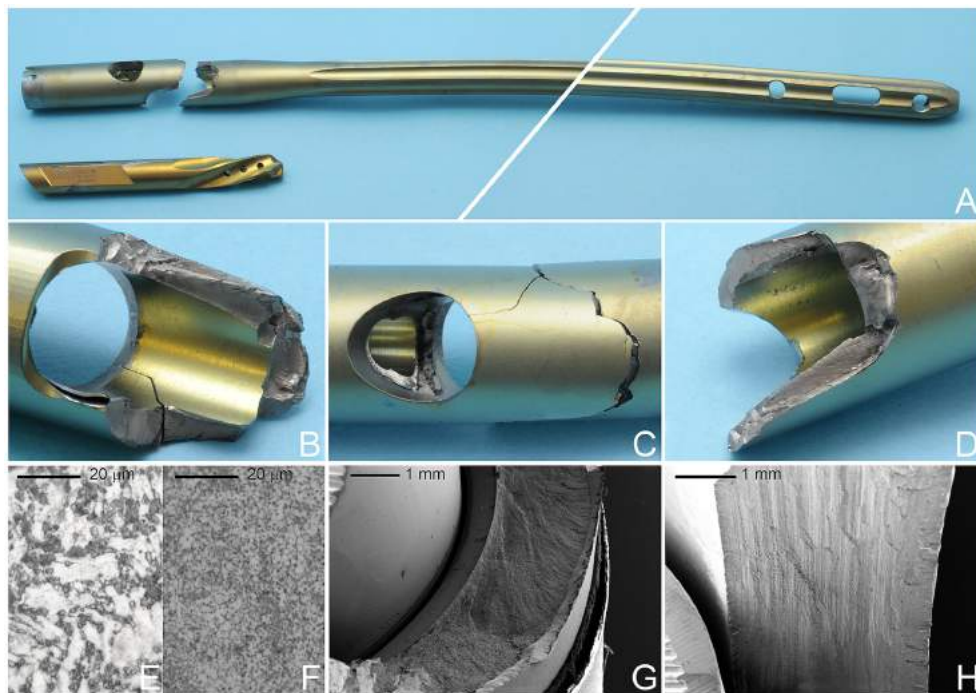
Figure 7.1 Appearance of a Typical TFNA on Retrieval Examination

Macroscopic analysis of the TFNA nails primarily revealed a tortuous crack failure path with all nails showing multiple secondary cracks stemming from the fracture surfaces. In this regard several nails had evidence of small fragments of alloy missing from the fracture surface, indicative of multiple crack pathways. In all cases, part of the failure path included fracture surfaces running parallel to the long axis of the nail (Fig. 6).

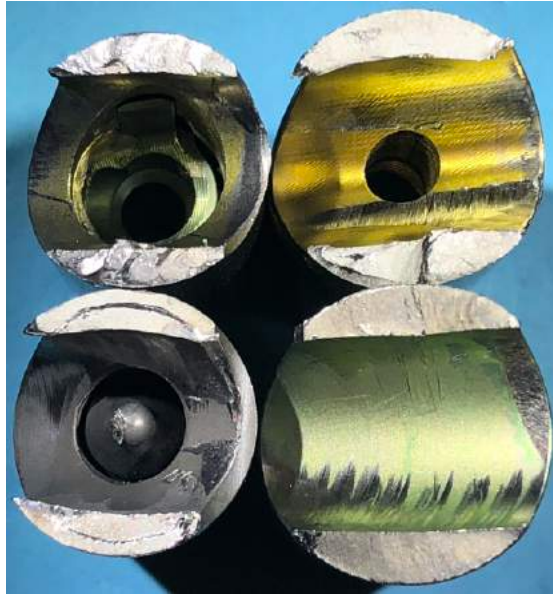
Figure 7.2 Cross Sectional Microscope Photograph of Broken Nails

In comparison to previous generations of Synthes nails or to the Stryker Gamma nail, there appeared to be a significant macroscopic reduction in alloy volume around the proximal aperture as pictured in Figure 7.2. Examining the nail design there was no evidence of a SIG-like etching of the outer aperture as seen in Stryker Gamma nails and discussed in section 4.1.

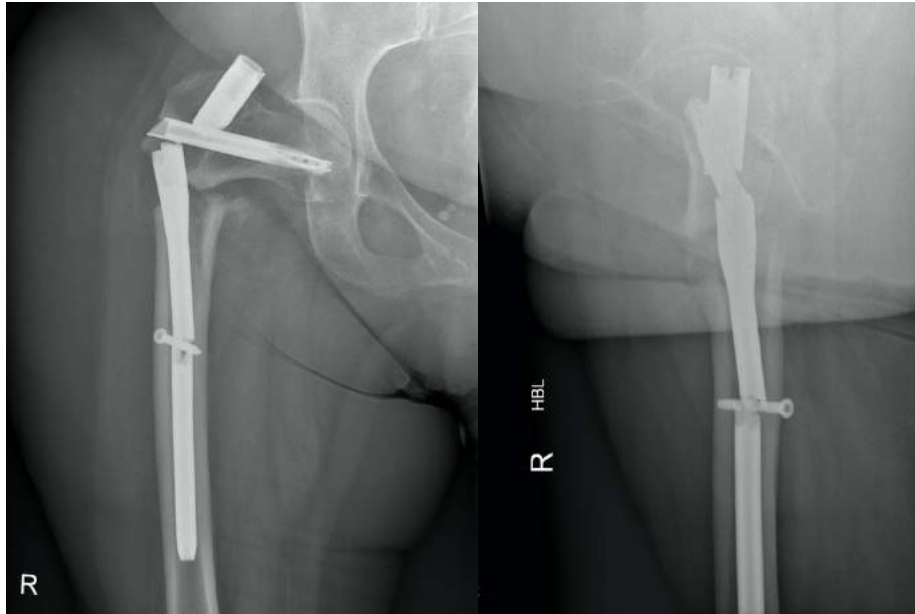
Figure 7.3 Post Breakage X-rays of Case 5

One case in particular demonstrated breakages through both the proximal and distal apertures, which had not been described previously in the orthopaedic literature Figure 7.3.

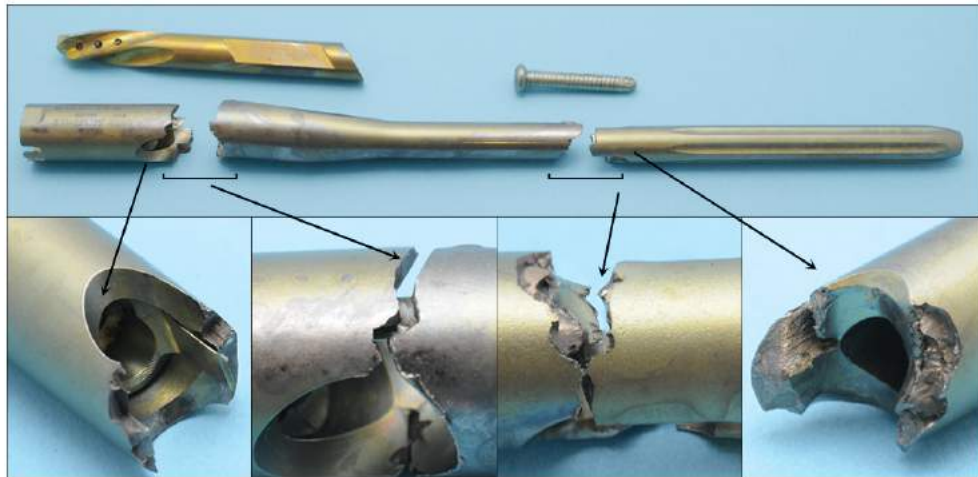
Figure 7.4 Case 5 Laboratory Photography

Analysis of the retrieved nail fragments illustrated an unusual pattern of fragmentation (Figure 7.4). The tortuous fracture path and missing fragments were characteristic of the titanium alloy and its inherent microstructure. It was hypothesised that the implant initially failed distally, suggesting that the proximal nail was not well supported, leading to increased bending loads at the level of the cross-locking screw.

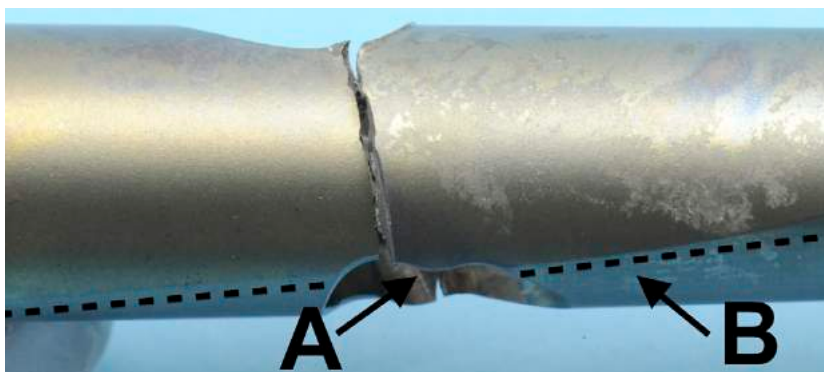
Fig. 1
Photograph of the anterior surface of the proximal portion of a broken nail. "A" indicates the BUMP CUT, and the dashed line ("B") indicates the LATERAL RELIEF CUT.

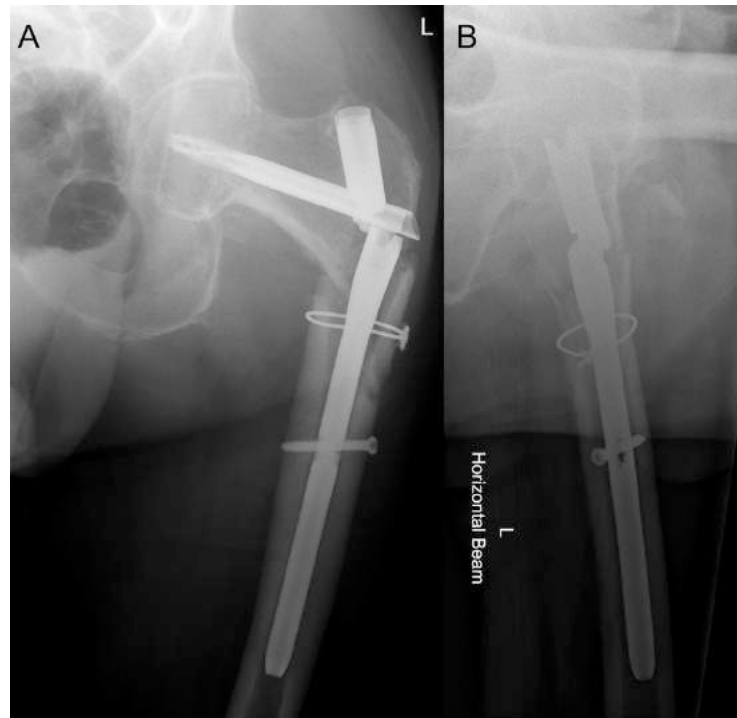
Fig. 4

Anteroposterior (**Fig. 4-A**) and lateral (**Fig. 4-B**) radiographs demonstrating implant breakage.
